REVISED
Comprehensive
Reserve Fund Study
2 Frame Crescent, Elliot Lake,
Ontario

Algoma Condominium Corporation
No. 13 (ACC 13)
2 Frame Crescent
Elliot Lake, ON P5A 2S5

September 11, 2015

Pinchin File: 103715

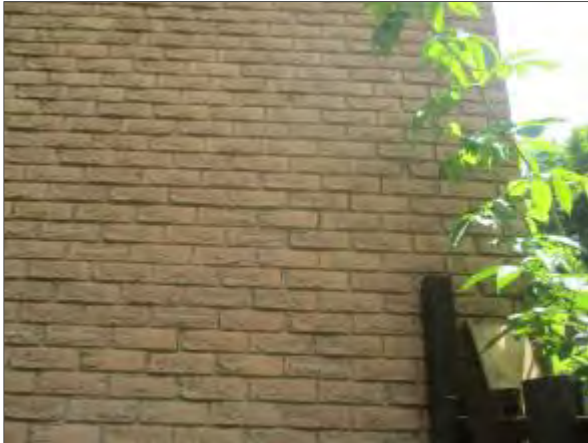
The majority of the exterior cladding on the townhouse blocks is comprised of brick veneer masonry cladding with minor areas of painted wood siding (discussed in section 3.5) on the attached sheds. The brick masonry walls are complete with weep holes to help drain any excess moisture within the wall cavity. This masonry is an original installation and was in generally good condition at the time of site review with the exception of a few noted deficiencies. Pinchin did note random minor holes within the mortar joints as well as other minor deficiencies. Isolated areas of major deficiencies were noted on the buildings including a large area of step cracking and differential movement on the north elevation of block number 5 (unit 52) as well as on the west elevation of block 15 (unit 19) below the second floor window. These major deficiencies should be corrected in the short term.

View of step cracking and differential movement noted in the brick masonry on the north elevation of block 5.

This brick masonry is from original construction and is now approximately 36 years old. Brick masonry is assumed to last the life of a building. However, localized repairs such as tuck pointing of mortar joints and rehabilitation of deteriorated brick will be required over time. Consequently, Pinchin has presented allowances for localized rehabilitation and replacement of deteriorated masonry as indicated in the 30 Year Repair/Replacement Forecast Table.

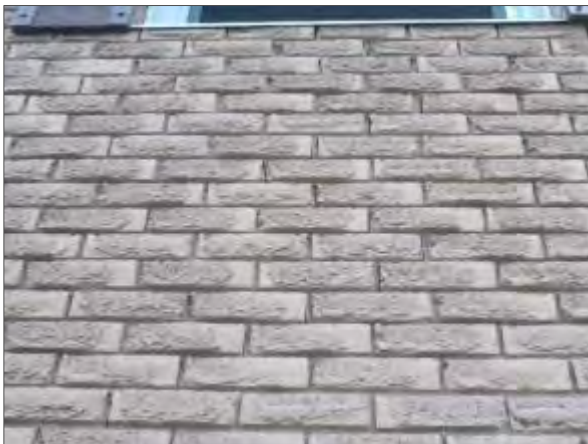
View of step cracking and differential movement noted in the brick masonry on the west elevation of block 15.

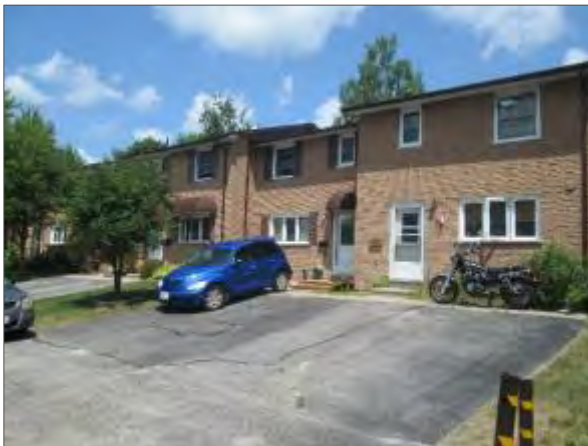
The townhouse units have been provided with asphalt on grade driveways. These asphalt driveways are an original installation and were in generally in fair condition at the time of site review. Pattern cracking was observed at the driveway/curb interface on a majority of the driveways. Areas of crack sealing repairs have been performed since the original date of installation. Pinchin noted that a portion of the driveways have been sealed, however it was reported that sealing of the driveways is an owner responsibility.

View of the typical asphalt paved driveways serving the units with typical pattern cracking observed.

The normal life expectancy of asphalt driveways of this type is in the order of 20 to 25 years, depending on the quality of pavement and installation procedures. As well, regular cleaning of vehicle fluids should be completed to ensure long term serviceability; however, this is typically unit owner responsibility. Based on this, Pinchin has presented an allowance for future replacement as indicated in the 30 year Repair/Replacement Forecast Table.
