REVISED
Comprehensive
Reserve Fund Study
2 Frame Crescent, Elliot Lake,
Ontario

Algoma Condominium Corporation
No. 13 (ACC 13)
2 Frame Crescent
Elliot Lake, ON P5A 2S5

September 11, 2015

Pinchin File: 103715

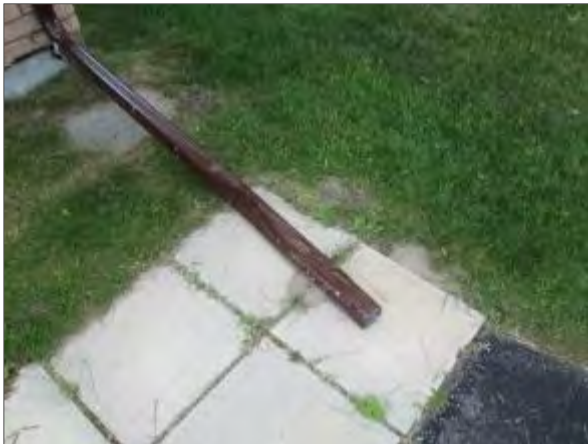
Drainage for the roofs on the unit blocks as well as the backyard sheds is provided by metal gutters and downspouts. These gutters and downspouts were reportedly all replaced or repaired at the time of the roof replacements between 2012 and 2014. A portion of the downspouts and extensions were noted to be damaged during the site visit.

View of a typical crushed downspout extension.

It is assumed that these damaged sections of downspout pipes and extensions will be repaired as part of the operating budget for the corporation. Metal gutters and downspouts will typically have a service life in the order of 20-30 years provided that regular maintenance such as cleaning is carried out. Based on this, Pinchin has carried for replacements within the 30 Year Repair/Replacement Forecast Table as the gutters and downspouts are currently 1 to 3 years old and are expected to perform satisfactorily until the scheduled roof replacements are completed. It is assumed that minor repairs and replacements will be

required due to damage caused by pedestrians or vehicles which should be repaired through the operating budget for ACC 13.

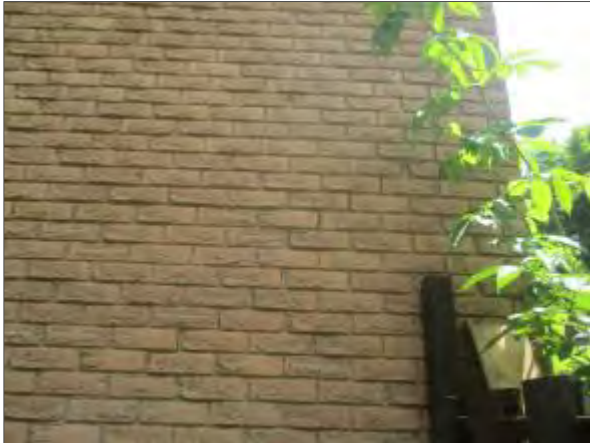
The majority of the exterior cladding on the townhouse blocks is comprised of brick veneer masonry cladding with minor areas of painted wood siding (discussed in section 3.5) on the attached sheds. The brick masonry walls are complete with weep holes to help drain any excess moisture within the wall cavity. This masonry is an original installation and was in generally good condition at the time of site review with the exception of a few noted deficiencies. Pinchin did note random minor holes within the mortar joints as well as other minor deficiencies. Isolated areas of major deficiencies were noted on the buildings including a large area of step cracking and differential movement on the north elevation of block number 5 (unit 52) as well as on the west elevation of block 15 (unit 19) below the second floor window. These major deficiencies should be corrected in the short term.

View of step cracking and differential movement noted in the brick masonry on the north elevation of block 5.

This brick masonry is from original construction and is now approximately 36 years old. Brick masonry is assumed to last the life of a building. However, localized repairs such as tuck pointing of mortar joints and rehabilitation of deteriorated brick will be required over time. Consequently, Pinchin has presented allowances for localized rehabilitation and replacement of deteriorated masonry as indicated in the 30 Year Repair/Replacement Forecast Table.

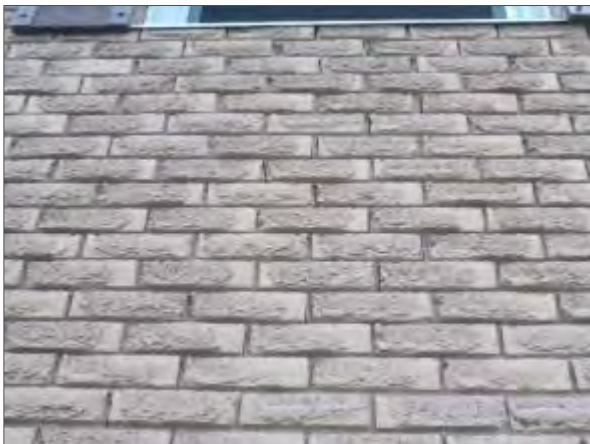
View of step cracking and differential movement noted in the brick masonry on the west elevation of block 15.

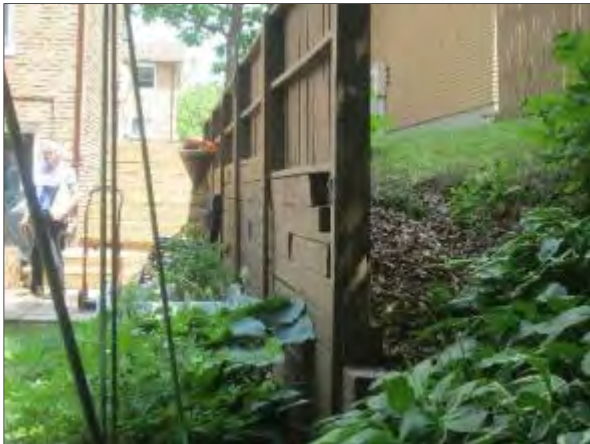
Site. The retaining wall between blocks 7 and 8 was noted to be leaning at the time of the assessment and will require replacement in the short term.

View of the wood framed retaining wall between blocks 7 and 8 which was noted to be leaning and will require replacement in the short term.

The upgrading/rehabilitation of landscaping is typically driven by unit owners and board to enhance curb appeal of the complex. Pinchin has presented a contingency allowance for this work as indicated in the 30 Year Repair/Replacement Forecast Table as well as future replacement costs for the retaining wall between blocks 7 and 8.
