REVISED
Comprehensive
Reserve Fund Study
2 Frame Crescent, Elliot Lake,
Ontario

Algoma Condominium Corporation
No. 13 (ACC 13)
2 Frame Crescent
Elliot Lake, ON P5A 2S5

September 11, 2015

Pinchin File: 103715

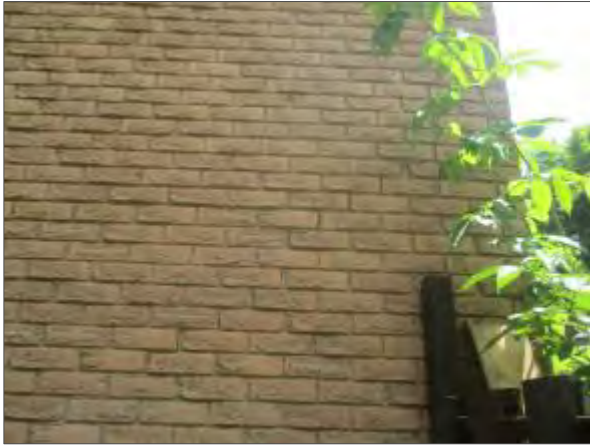
The majority of the exterior cladding on the townhouse blocks is comprised of brick veneer masonry cladding with minor areas of painted wood siding (discussed in section 3.5) on the attached sheds. The brick masonry walls are complete with weep holes to help drain any excess moisture within the wall cavity. This masonry is an original installation and was in generally good condition at the time of site review with the exception of a few noted deficiencies. Pinchin did note random minor holes within the mortar joints as well as other minor deficiencies. Isolated areas of major deficiencies were noted on the buildings including a large area of step cracking and differential movement on the north elevation of block number 5 (unit 52) as well as on the west elevation of block 15 (unit 19) below the second floor window. These major deficiencies should be corrected in the short term.

View of step cracking and differential movement noted in the brick masonry on the north elevation of block 5.

This brick masonry is from original construction and is now approximately 36 years old. Brick masonry is assumed to last the life of a building. However, localized repairs such as tuck pointing of mortar joints and rehabilitation of deteriorated brick will be required over time. Consequently, Pinchin has presented allowances for localized rehabilitation and replacement of deteriorated masonry as indicated in the 30 Year Repair/Replacement Forecast Table.

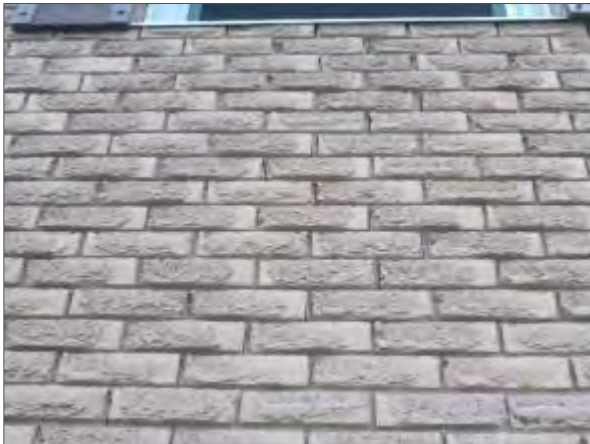
View of step cracking and differential movement noted in the brick masonry on the west elevation of block 15.

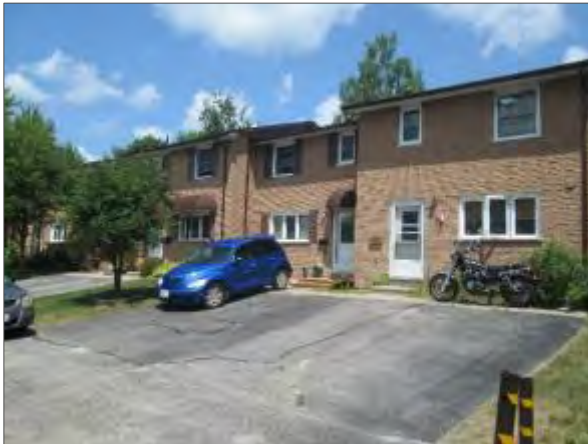
The townhouse units have been provided with asphalt on grade driveways. These asphalt driveways are an original installation and were in generally in fair condition at the time of site review. Pattern cracking was observed at the driveway/curb interface on a majority of the driveways. Areas of crack sealing repairs have been performed since the original date of installation. Pinchin noted that a portion of the driveways have been sealed, however it was reported that sealing of the driveways is an owner responsibility.

View of the typical asphalt paved driveways serving the units with typical pattern cracking observed.

The normal life expectancy of asphalt driveways of this type is in the order of 20 to 25 years, depending on the quality of pavement and installation procedures. As well, regular cleaning of vehicle fluids should be completed to ensure long term serviceability; however, this is typically unit owner responsibility. Based on this, Pinchin has presented an allowance for future replacement as indicated in the 30 year Repair/Replacement Forecast Table.

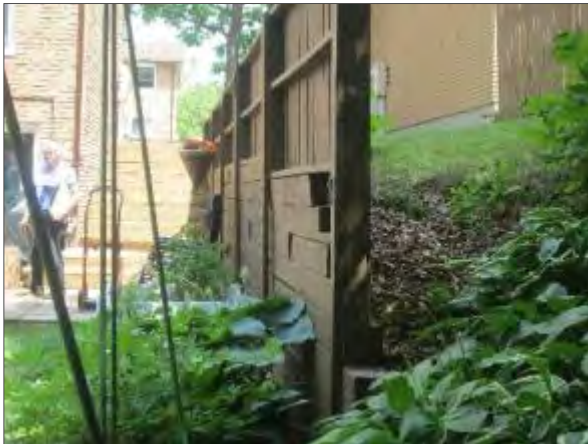
Site. The retaining wall between blocks 7 and 8 was noted to be leaning at the time of the assessment and will require replacement in the short term.

View of the wood framed retaining wall between blocks 7 and 8 which was noted to be leaning and will require replacement in the short term.

The upgrading/rehabilitation of landscaping is typically driven by unit owners and board to enhance curb appeal of the complex. Pinchin has presented a contingency allowance for this work as indicated in the 30 Year Repair/Replacement Forecast Table as well as future replacement costs for the retaining wall between blocks 7 and 8.
